AFFIDAVIT OF MICHAEL CANNON

March 11, 2019

RE: Ms. Janice Scott- Insured
1590 Foote Street NE
Atlanta, Georgia 30307
Claim No. HL95871
Water Damage Causation Investigation
Forcon No. G19336

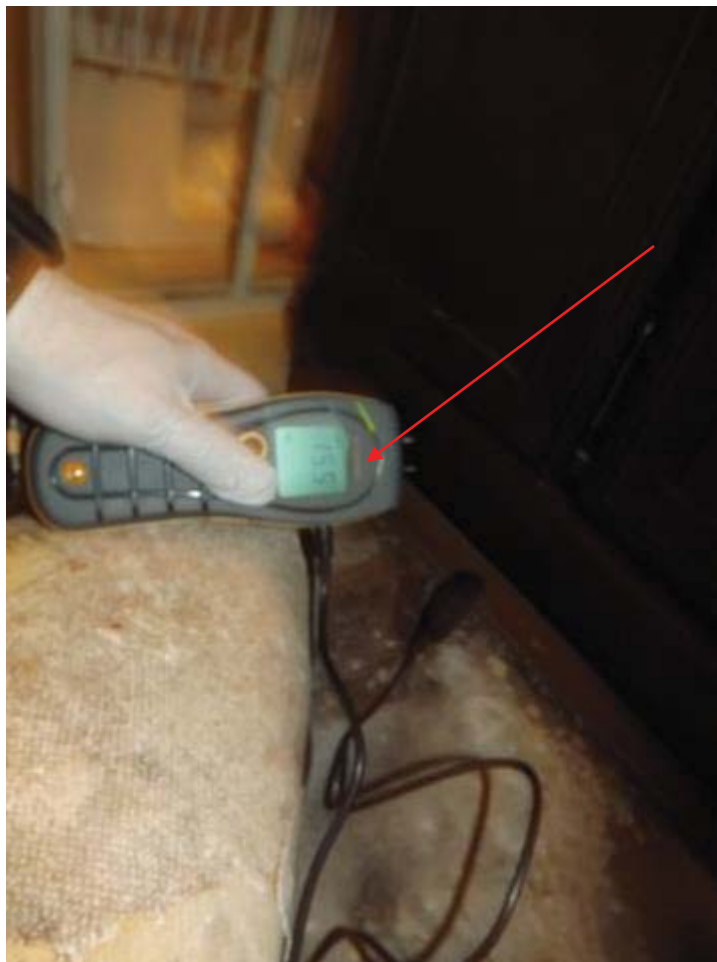
Photograph 40- Dry Moisture Meter Reading from Delaminated Subfloor to Left of Bathroom Vanity Sink Cabinet

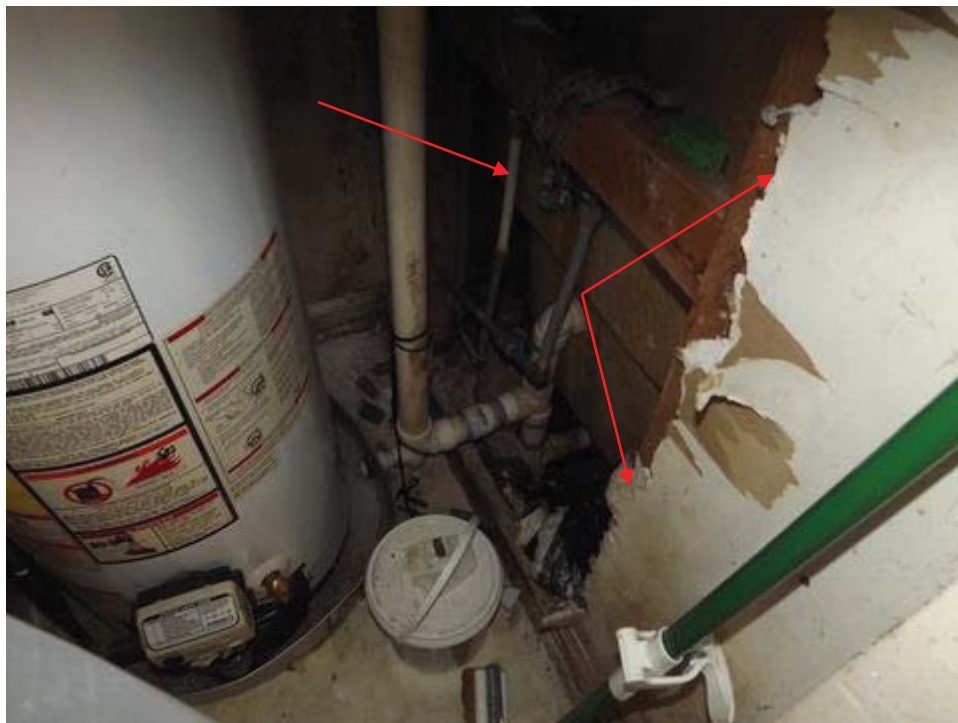
Photograph 42- General View of Hot Water Heater Closet with Torn Out Drywall and Visible Plumbing Repair to Cold Water Line to Bathtub Mixing Valve

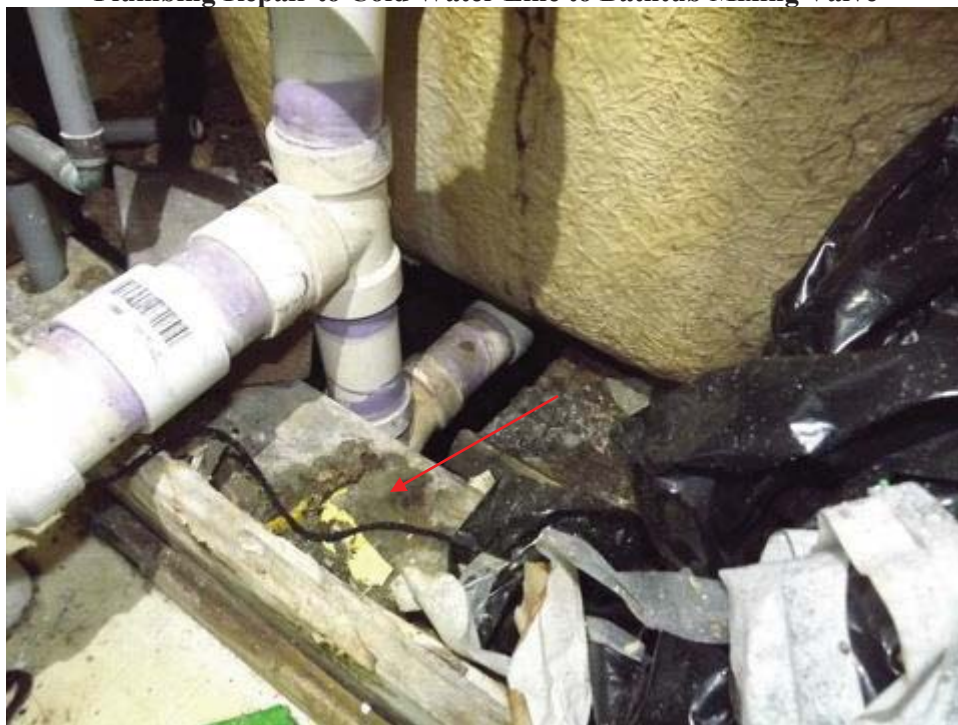
Photograph 43- Visible Debris with Wet Sill Plate from Water Leak to Hot Water Line Fitting to Bathtub Mixing Valve Above Shown in Photo 45

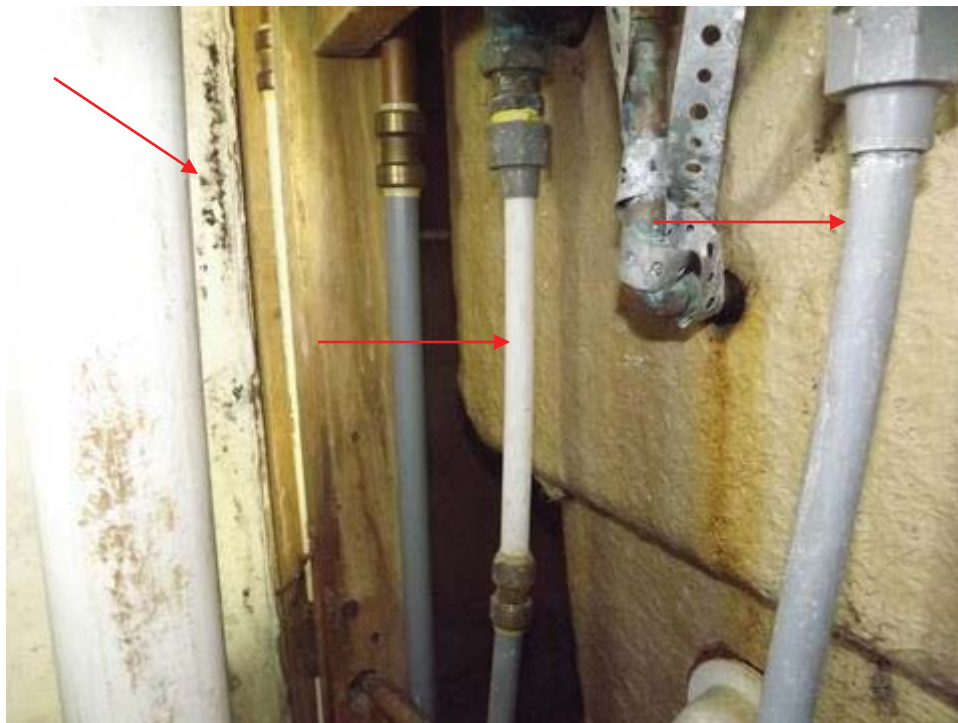
During my inspection, I observed that there had been repairs to the plumbing related to the hot water heater and bathtub. There was visible scattered dark mold growth on the drywall in the back right corner of the hot water heater closet that was likely caused by the previous leaks that had been repaired.

Photograph 44- Closer View of White PVC Repair to Cold Water Line Serving Bathtub Mixing Valve- Note: Hot Water Polybutylene Line to Right and Dark Visible Mold Growth on Drywall in Corner to Left

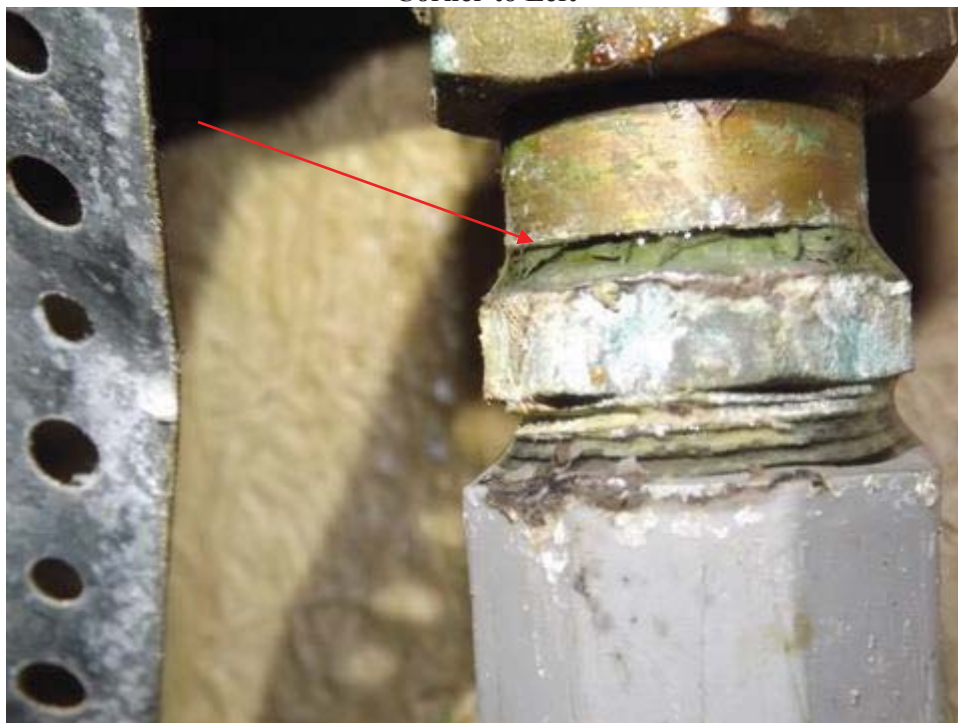
Photograph 45- Water Leak/Weeping Fitting To Hot Water Line Serving Bathtub Mixing Valve

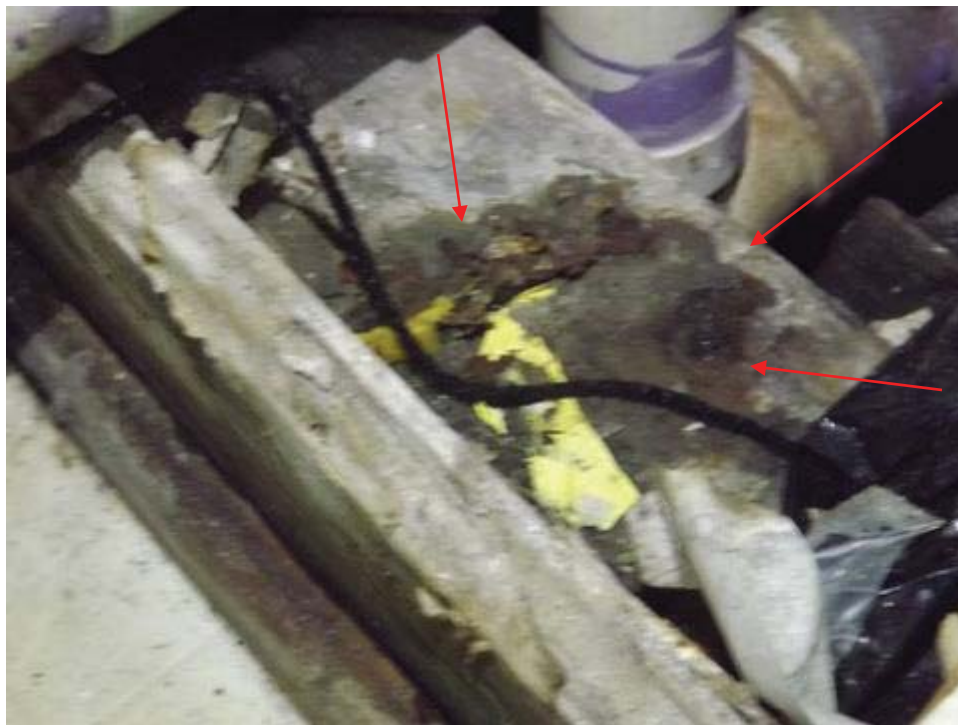
Photograph 46- Closer View of Water Drip Footprint on Sill Plate Beneath Hot Water Line Shown in Photo 45

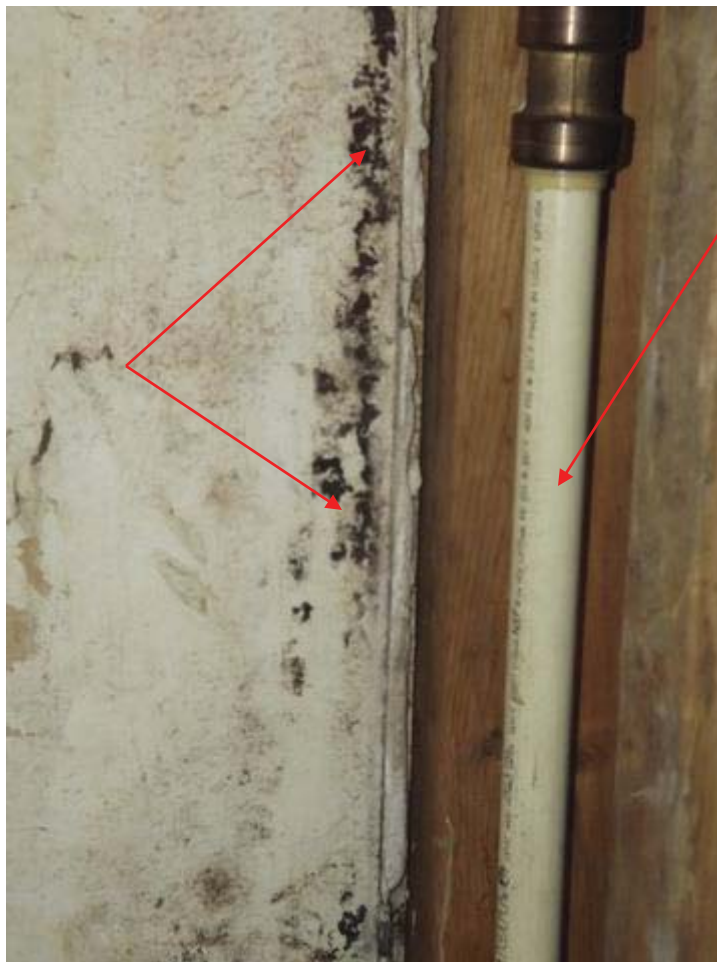
Photograph 47- View of CPVC Water Line Repair for Line Serving Hot Water Heater with Visible Scattered Visible Mold Growth on Drywall- This Mold Was Caused By Water Leak Events that Occurred in the Hot Water Heater Closet

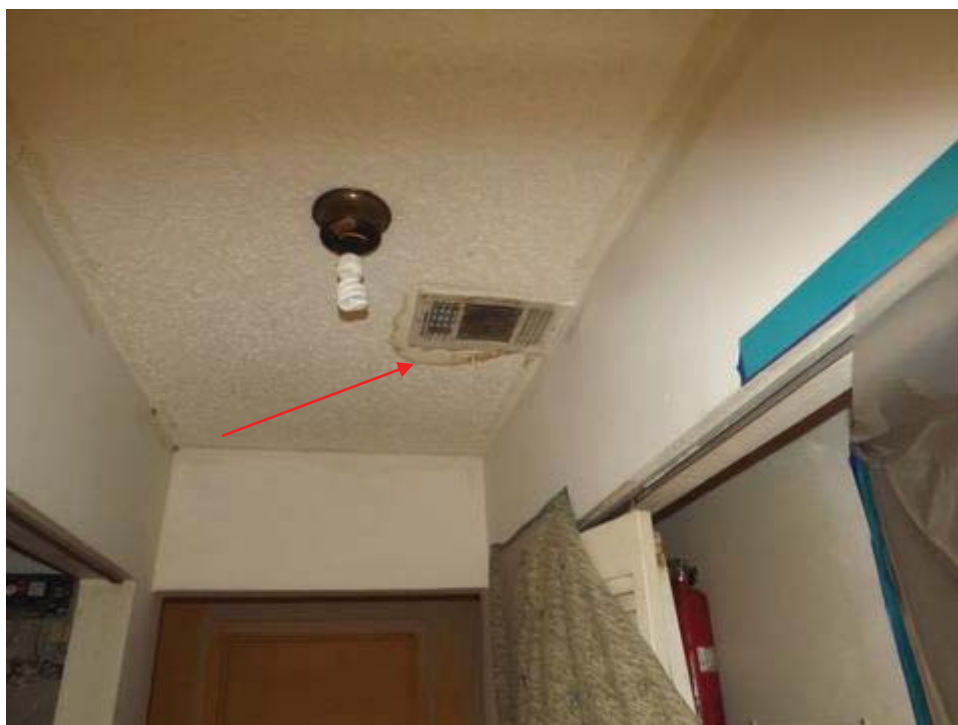
Photograph 52-Water Stains Around HVAC Supply Vent in Hallway to Bathroom, Laundry Closet and Hot Water Heater Closet

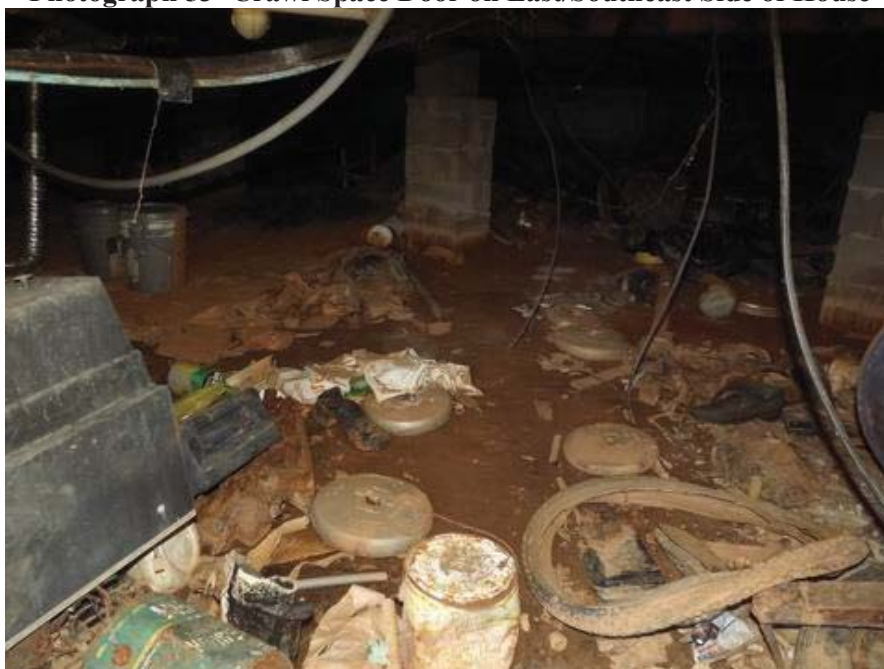
Photograph 54- General View of Crawl Space with Contents Debris and No Vapor Barrier Over Soil

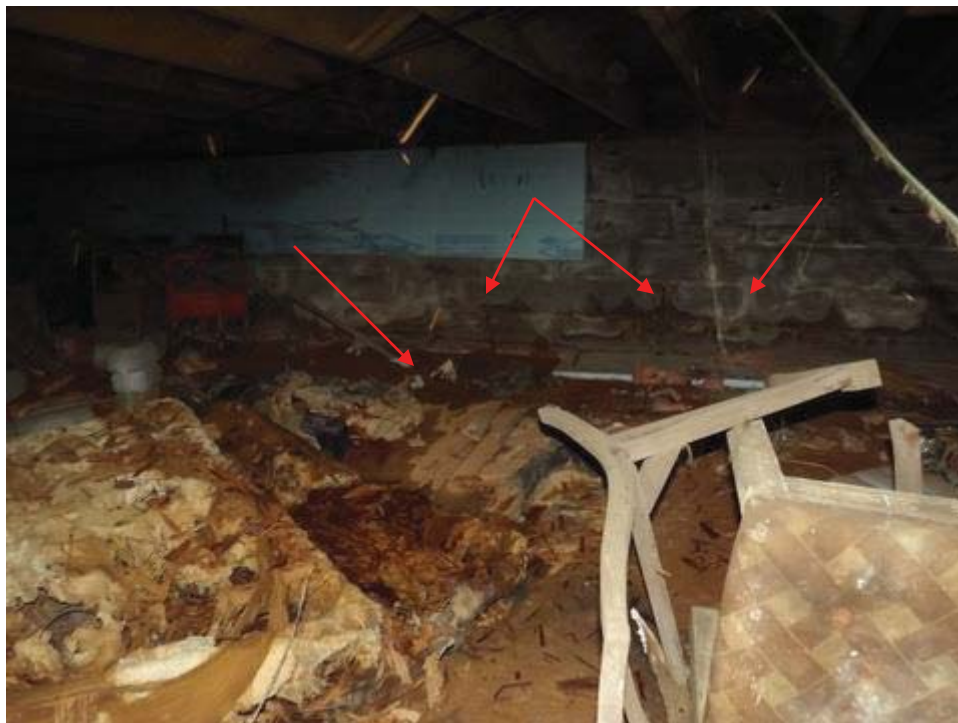
- 6) The crawl space had no vapor barrier over the soil or fiberglass insulation between the floor joists. There were miscellaneous contents scattered over the crawl space soil. There was evidence of water infiltration along the foundation wall between the north and west corners of the house that was below grade. This evidence included water stains on the CMU's, white efflorescence on the CMU's and muddy soil along the base of this foundation wall. There was visible mold on the subfloor and floor joists near this portion of the foundation that was likely caused by this water infiltration.

Photograph 55- View of North/Northwest Foundation Wall Below Grade with Visible Evidence of Water Infiltration- Water Stains and White Efflorescence and Muddy Soil

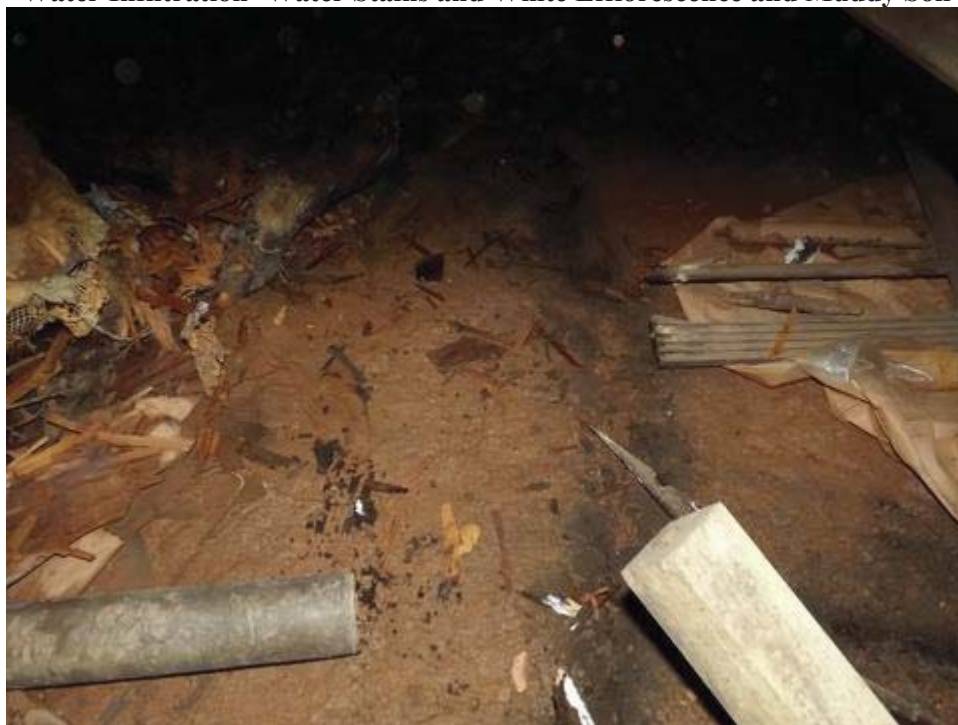
Photograph 56-Wet Crawl Space Soil

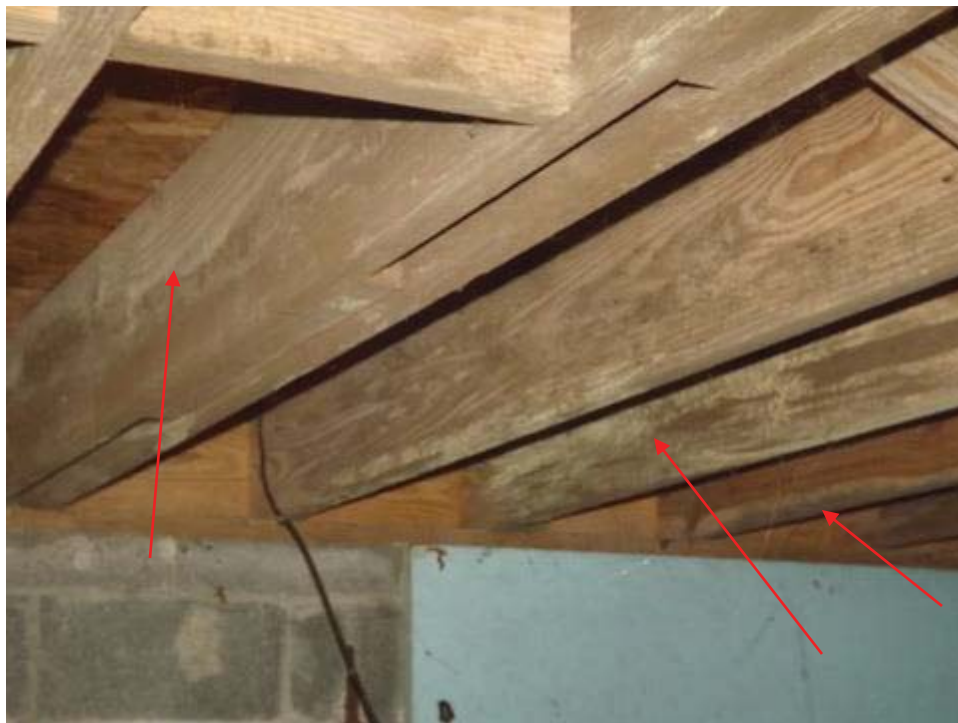
Photograph 57- Visible Mold Growth on Floor Joists in Vicinity of Wet Foundation Conditions Shown in Photo 55

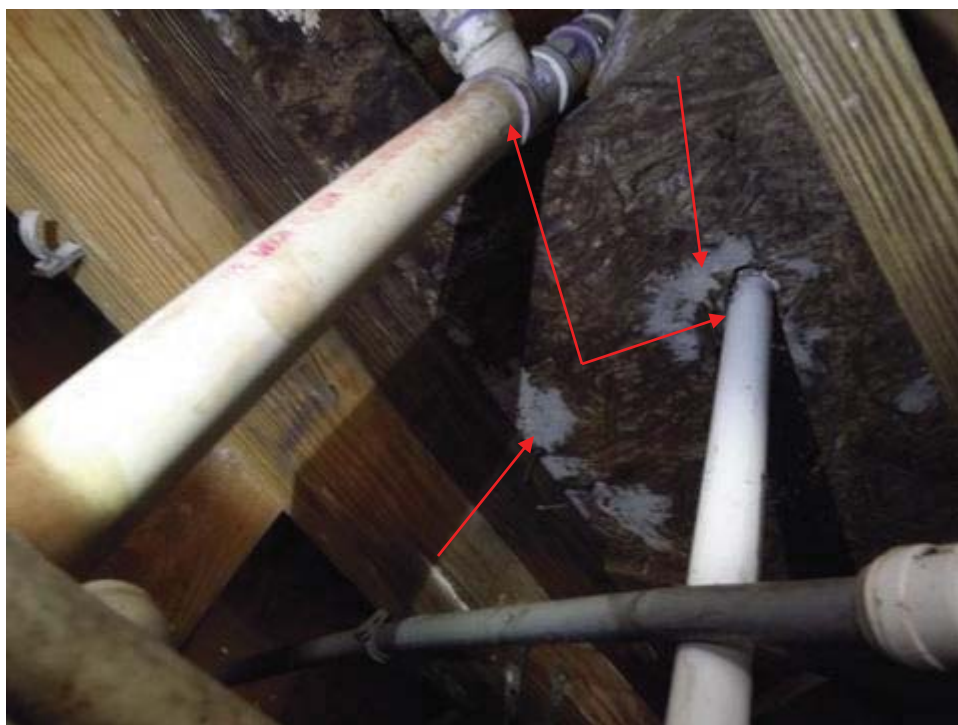
Photograph 58- Visible Water Stains/Damage and Mold Growth to Subfloor Beneath Hot Water Heater Closet with Bathtub Drain To Left and Drain to Containment Pan to Right

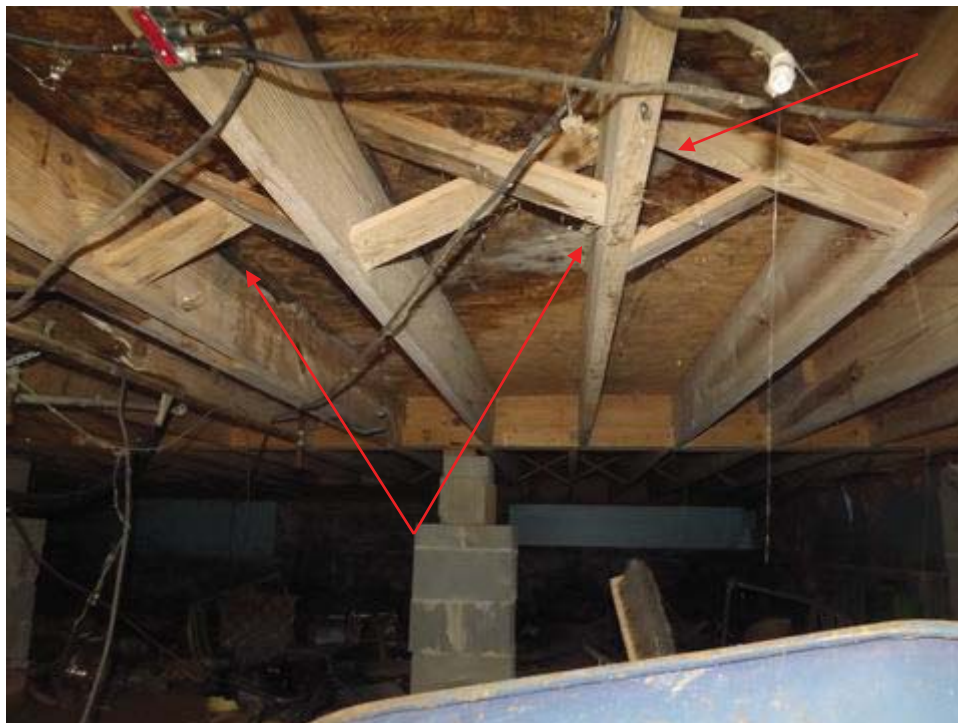
There was visible water damaged and mold contaminated subfloor and floor joists that extended from the area beneath the hot water heater closet into the back right corner bedroom (master bedroom). Moisture meter measurements from the water stained subfloor and floor joists in and around the hot water closet measured dry to at risk.

Photograph 59- View of Water Stain/Damage and Mold Growth on Subfloor Migrating From the Hot Water Heater Closet on Left to the Master Bedroom on Right

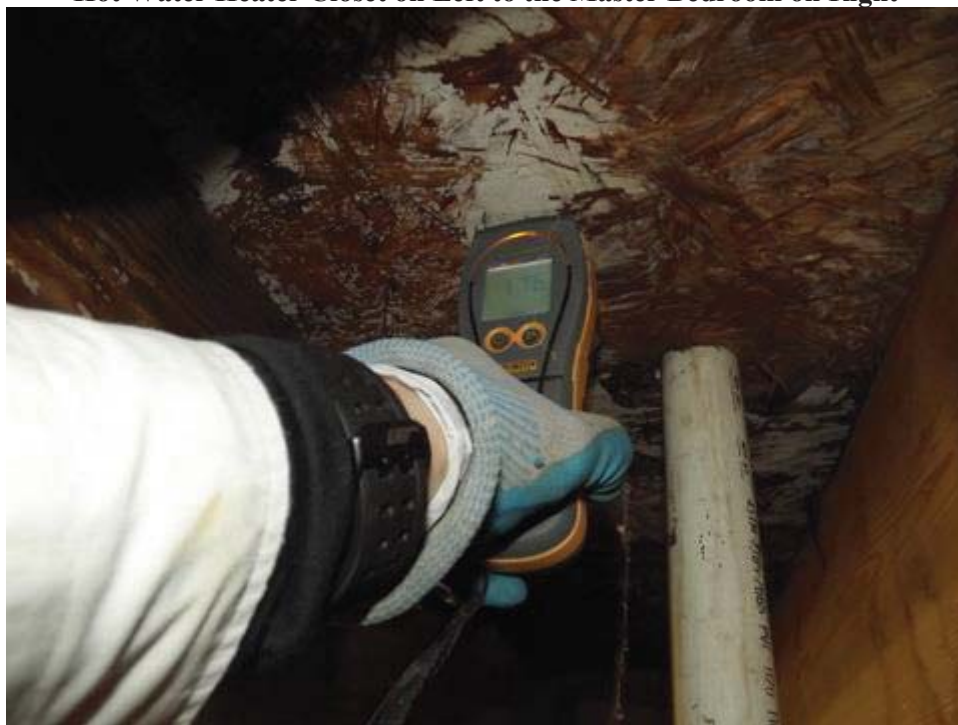
Photograph 60- At Risk Moisture Meter Reading From Subfloor in Crawl Space

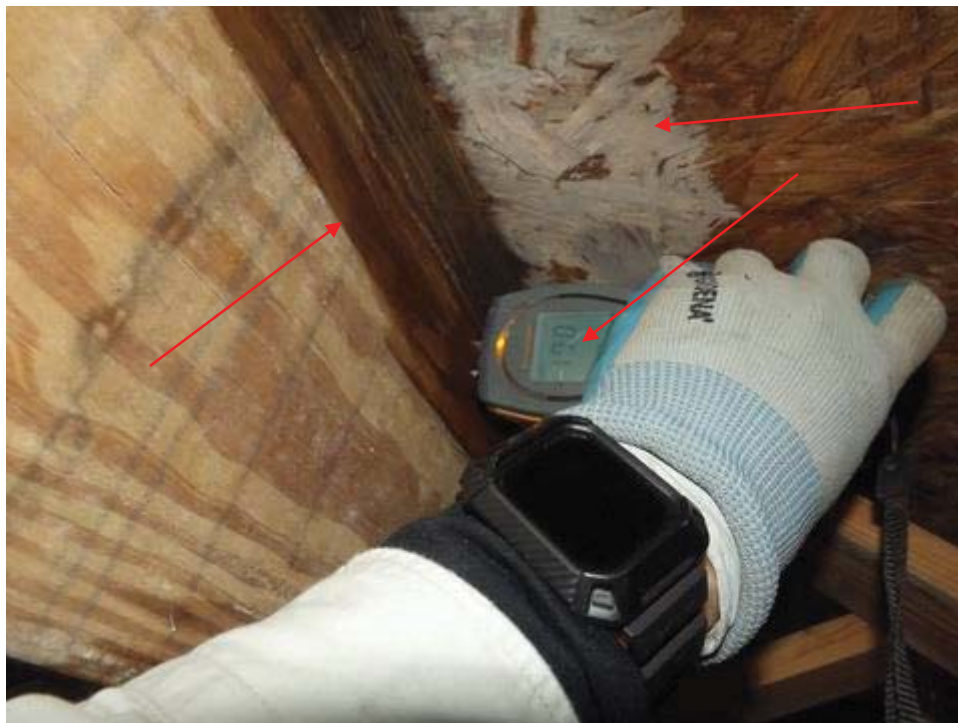
Photograph 61- Visible Water Stain and Mold Growth on Subfloor and Floor Joist Next Beneath Hot Water Closet with At Risk Moisture Meter Reading

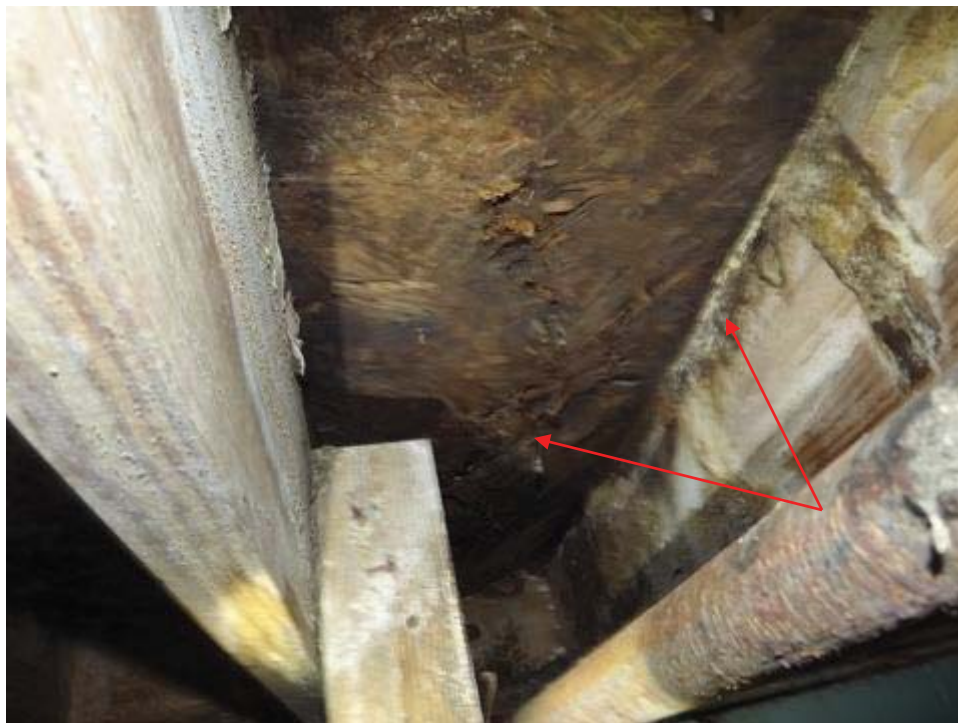
Based on my experience and training the failure of the subfloor behind and to the sides of the toilet indicated that this leak was long term.

Photograph 63- Collapsed Water Damaged Subfloor Beside (Right) and Behind Toilet with Visible Water Stains and Mold Growth

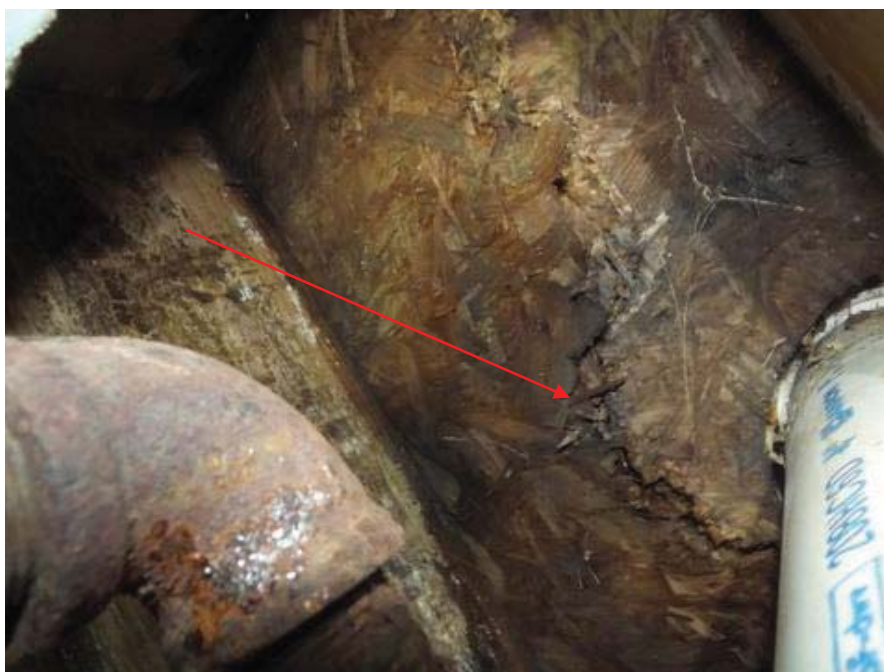
Photograph 64- Collapsed Water Damaged Subfloor Beside (Left) and Behind Toilet with Visible Water Stains and Mold Growth

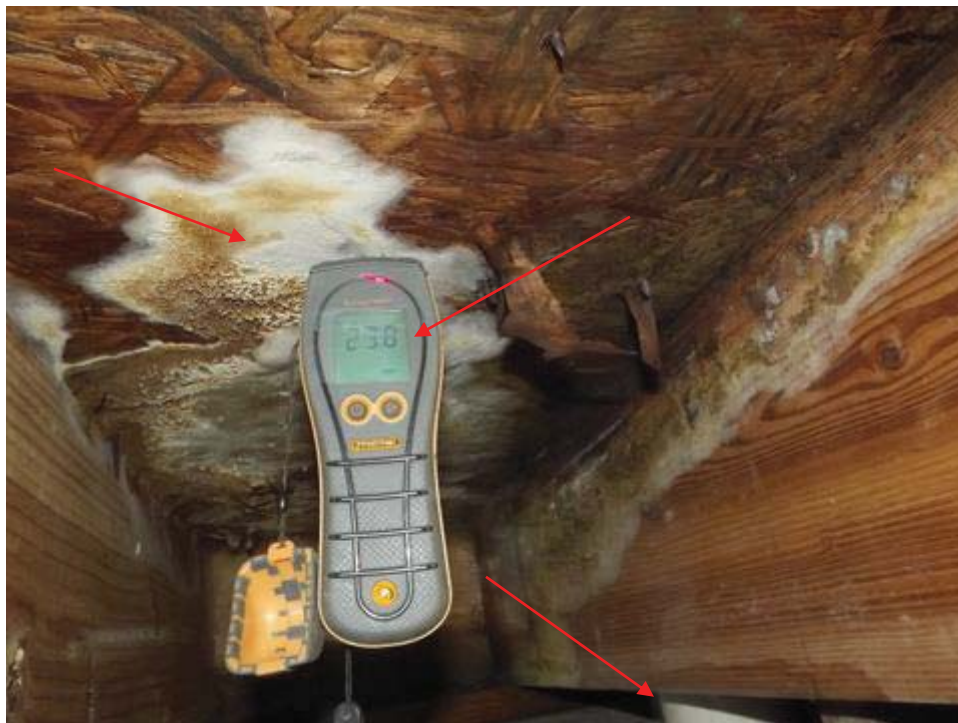
Photograph 65- Wet Moisture Meter Reading from Bathroom Subfloor in Front of Toilet with Mold Growth- Note: Toilet Drain Line to Right

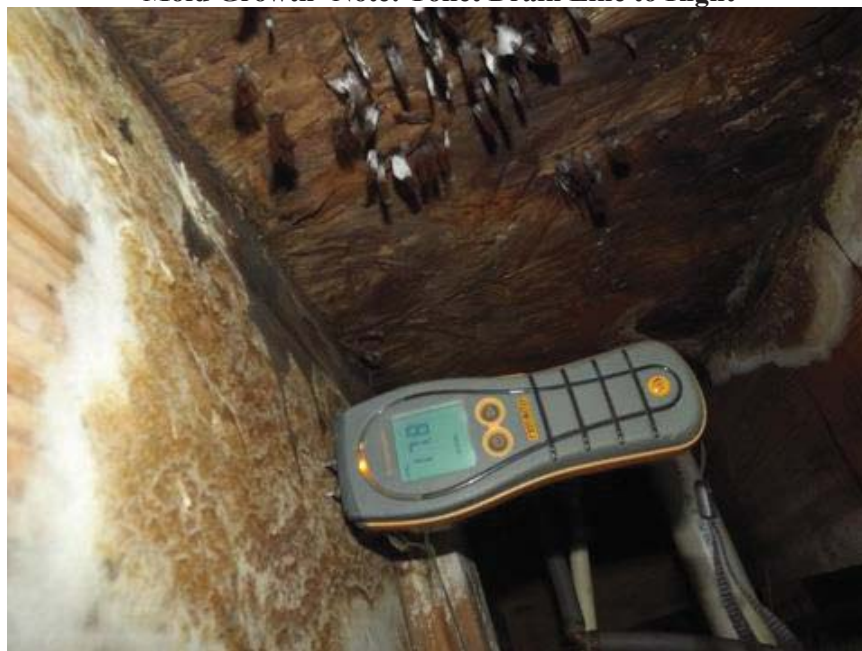
Photograph 66- At Risk Moisture Meter Reading from Floor Joist Beneath Bathroom with Visible Mold Growth on Subfloor and Floor Joist

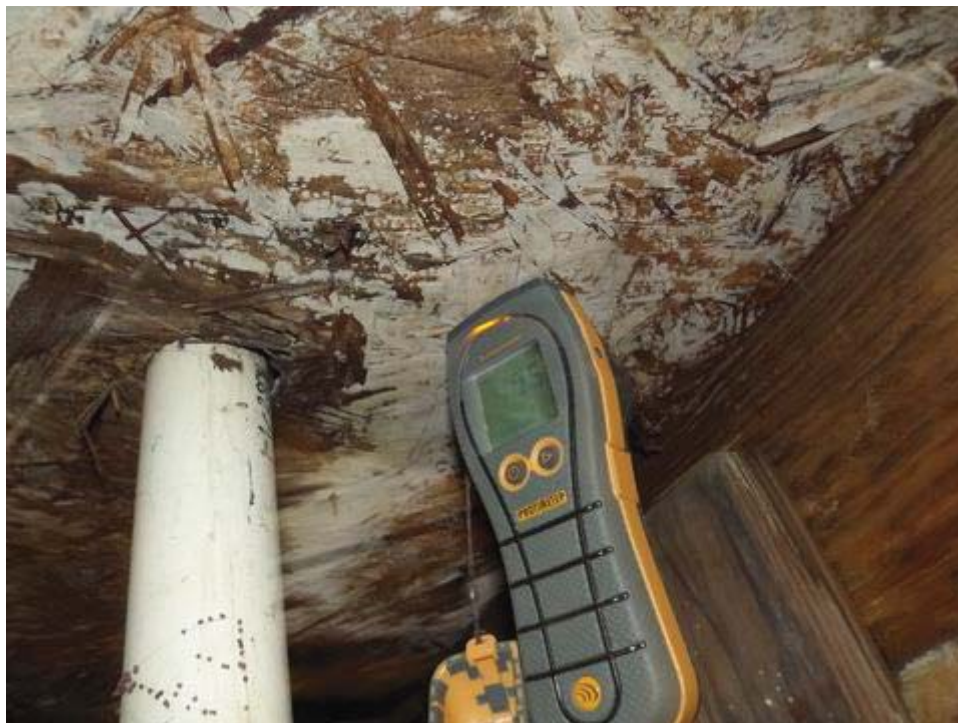
Photograph 67- At Risk Moisture Meter Reading from Subfloor with Mold Growth Near Drain Line to Bathroom

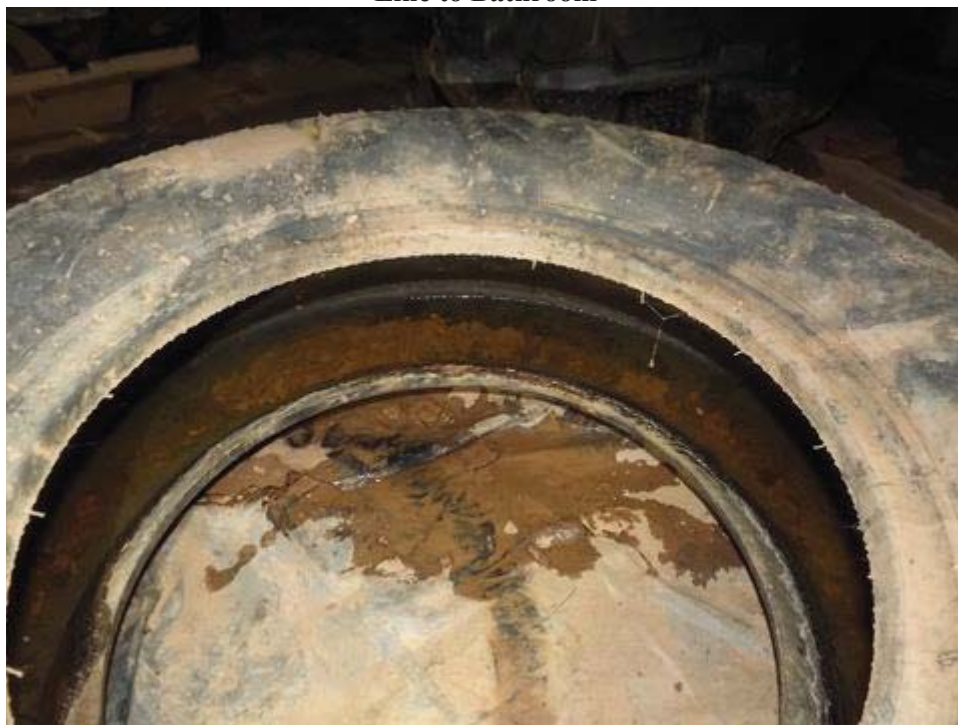
Photograph 68- Water Inside Tire Beneath Toilet

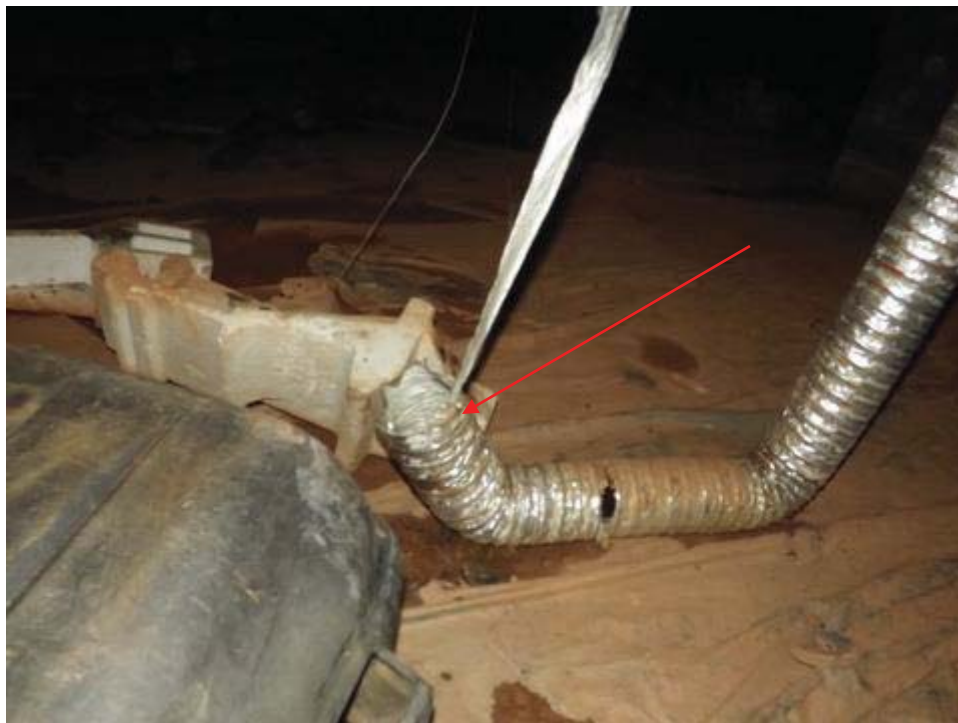
The flexible dryer vent hose to the clothes dryer had come apart and was exhausting into the crawl space. The hot moist air from this dryer vent hose would create conditions favorable for mold growth in the crawl space.

Photograph 69- Clothes Dryer Vent Exhausting to Crawl Space
